**THE APPLICABILITY OF THE NATIONAL ENVIRONMENTAL MANAGEMENT ACT, 1998 (ACT NO. 107 OF 1998) ("NEMA") AND THE ENVIRONMENTAL IMPACT ASSESSMENT ("EIA") REGULATIONS, 2014 (AS AMENDED) WITH RESPECT TO FARM NO. 225, MONTAGU**

**Field verification of a potential wetland proposed as a campsite on Montevue Nature Farm, Farm 225, Montagu, western Cape.**

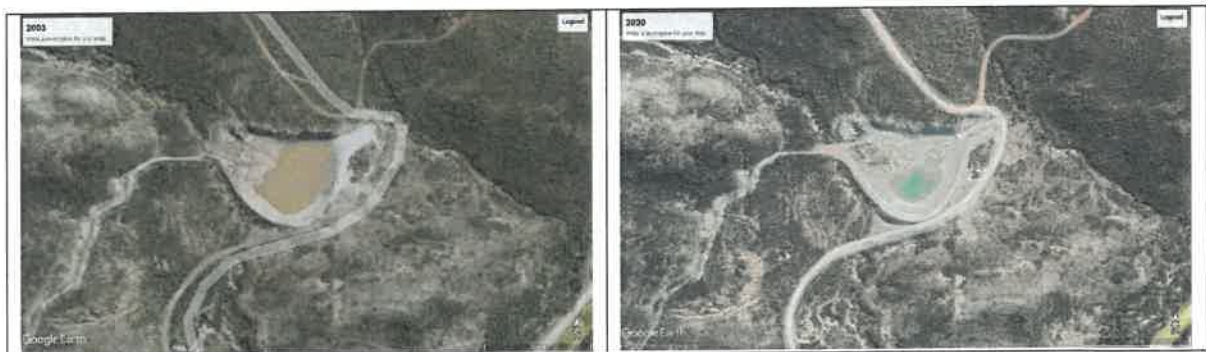
**Figure 3** -2003 compared to 2020

**EAP Comment:** It is an existing dam therefore 12 (i) do not apply. If the 2003 satellite image is compared to the 2020 picture it is clear that no new footprint was created even though the dam wall was repaired therefore 12(ii) also do not apply (**Figure 3**). The argument could be made that the dam wall is within 32 meters from the adjacent watercourse but as an existing dam wall that was repaired no additional impact was made on the water course. From the historic satellite images the EAP is of the opinion that it is not an instream dam. Therefore 12 (ii) a & c also do not apply. According to available information the origin of the dam was a quarry for road building.

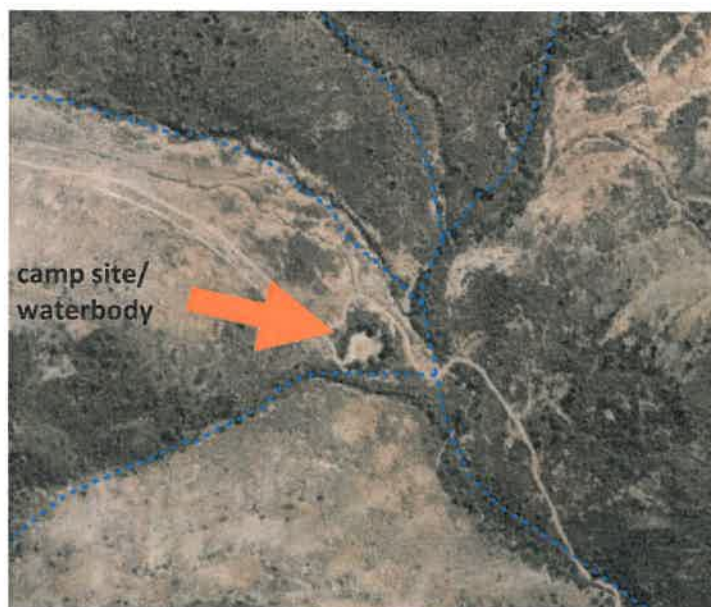
The camp site, identified as possible wetland, is surrounded by steep mountain slopes near the confluence of a system of ephemeral streams that meet to the south- east of the site (Figure 1).

**Figure 1** The camp site area identified as a possible wetland is situated at the base of a series of steep slopes near the confluence of a series of ephemeral streams.

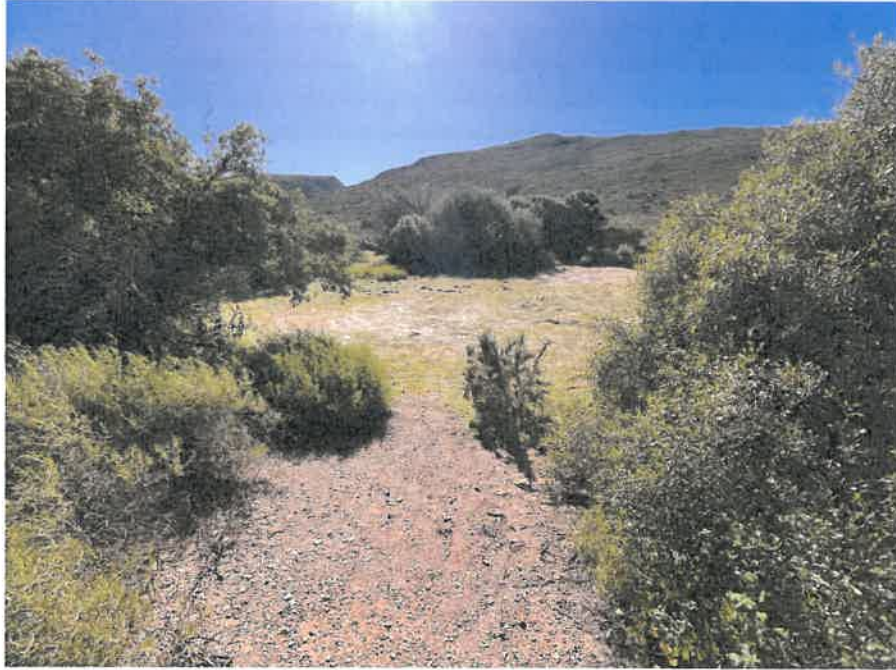
- The waterbody is surrounded by a man-made low berm, most prominent at its southern (downslope extent) that retains runoff and promotes inundation and saturation following rainfall events (Figure 5). The berm is vegetated with shrubs often found along the temporary margins of wetlands typical of arid regions of the western Cape, including *Searsia glauca*, *Searsia pendulina* and the false olive (*Buddleja saligna*).

**Figure 5** The waterbody is saturated within the lowlying central areas and is surrounded by a berm (seen in the foreground) to the south that retains runoff and results in periodic inundation and saturation.

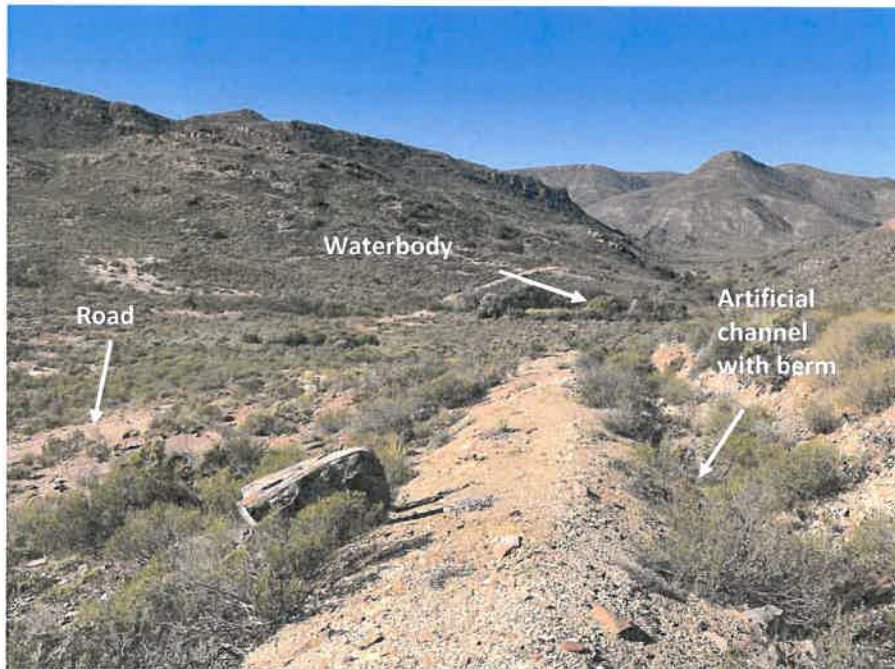
- The waterbody is fed primarily by a man-made channel that runs along the hillslope to the north-west (Figure 6). This channel captures sheet flow from the hillslope that then discharges into the waterbody (Figure 7).

**Figure 6** The artificially created channel at the base of the hillslope looking south with the waterbody in the distance. Runoff from the channel captures sheet flow that is directed to the waterbody.
